PASSAIC RIVER BASIN  
CLINTON BROOK, PASSAIC COUNTY  
NEW JERSEY

# CLINTON RESERVOIR DAM

NJ 00314

PHASE 1 INSPECTION REPORT  
NATIONAL DAM SAFETY PROGRAM

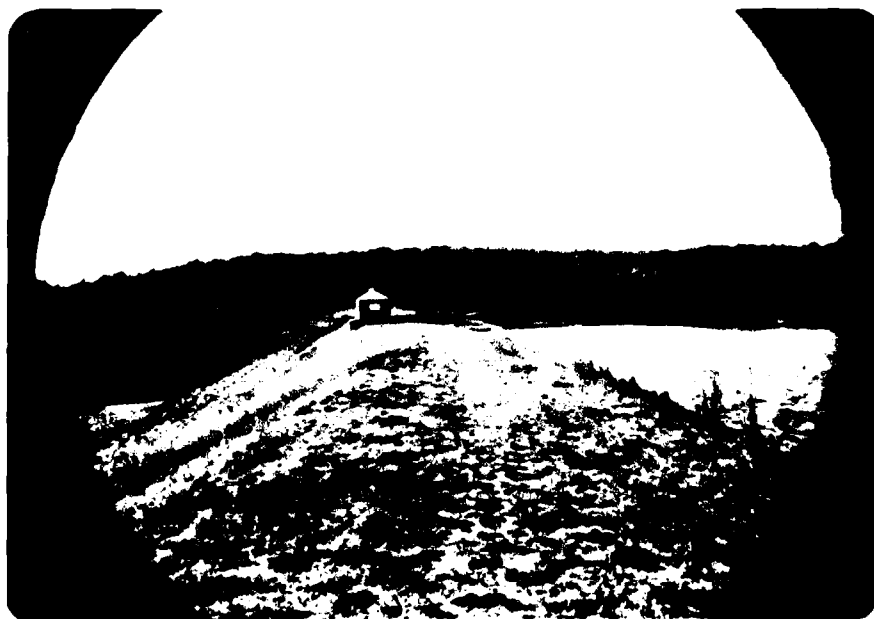
Photo 4 - View of embankment looking toward Valve House and right side of dam. The low level outlet channel, from Valve House, is visible at left center of photo. (Photo taken on November 14, 1979).

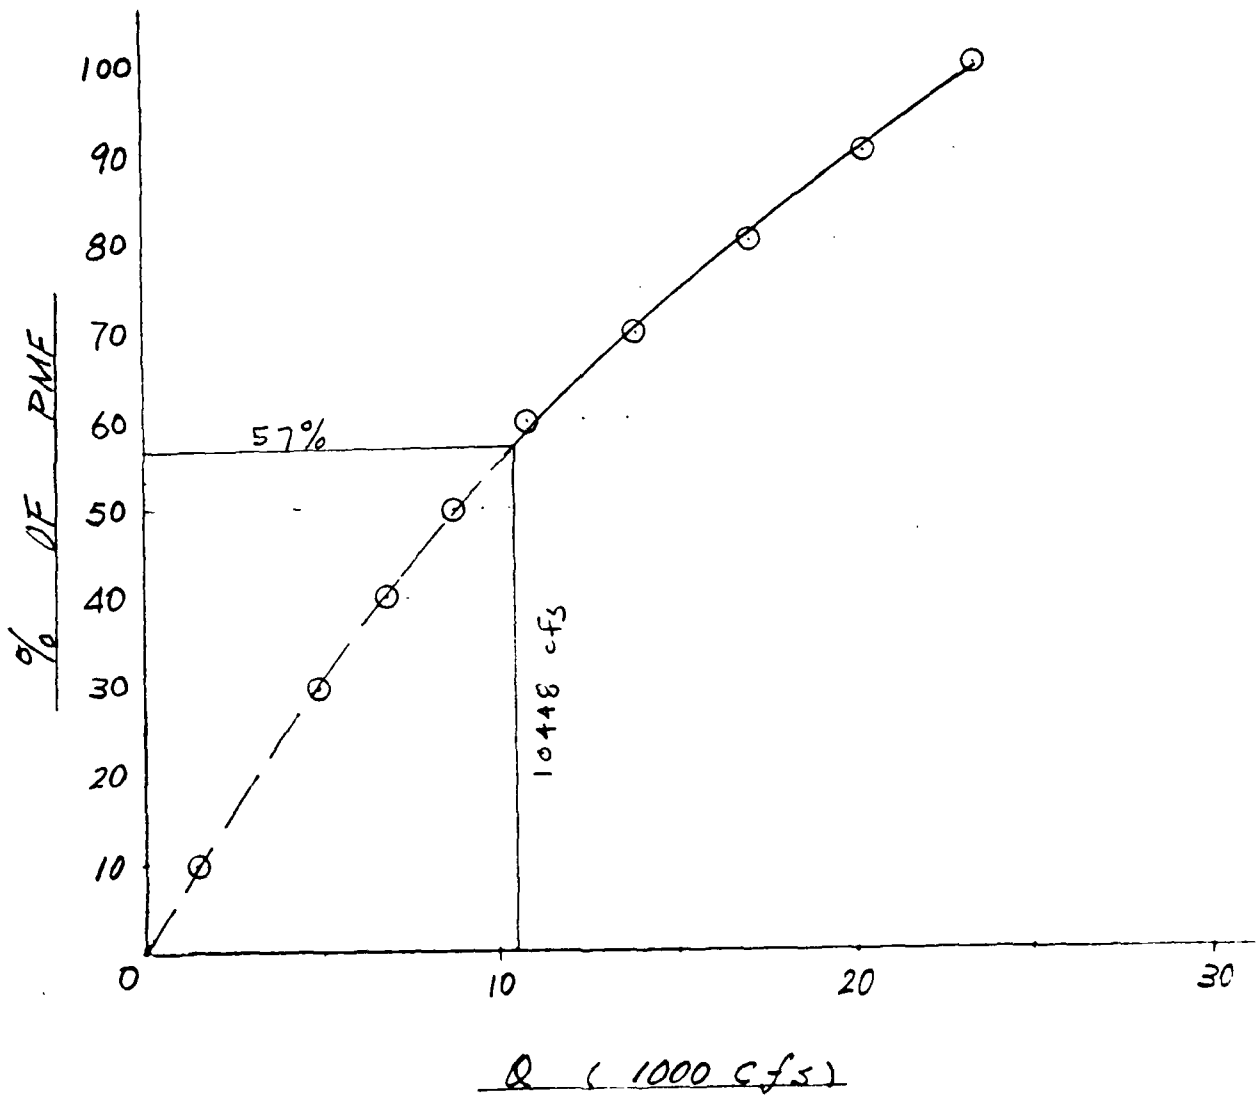
OVERTOPPING POTENTIAL

A storm of magnitude equivalent to the SDF would cause overtopping of the dam to a height of 1.76 feet. Computations indicate that the dam can pass approximately 57 percent of the PMF without overtopping the dam crest. Since the PMF is the Spillway Design Flood (SDF) for this dam, according to the "Recommended Guidelines for Safety of Dams" by the Corps of Engineers, the spillway capacity of the dam is assessed as "inadequate".

OVERTOPPING OF DAM OCCURS AT E. 57%  
WITH  $Q = 10.448 \text{ cfs}$  ( $\sim 57\% \text{ PMF}$ )
